THE NORWICH HISTORIC DISTRICT COMMISSION

CERTIFICATE OF APPROPRIATENESS: APPLICATION

Historic Property Address: 34 East Town Street, Norwich, CT 06360

**Energy Efficiency-HVAC Project
General Administration Building-34 East Town Street, Norwich**

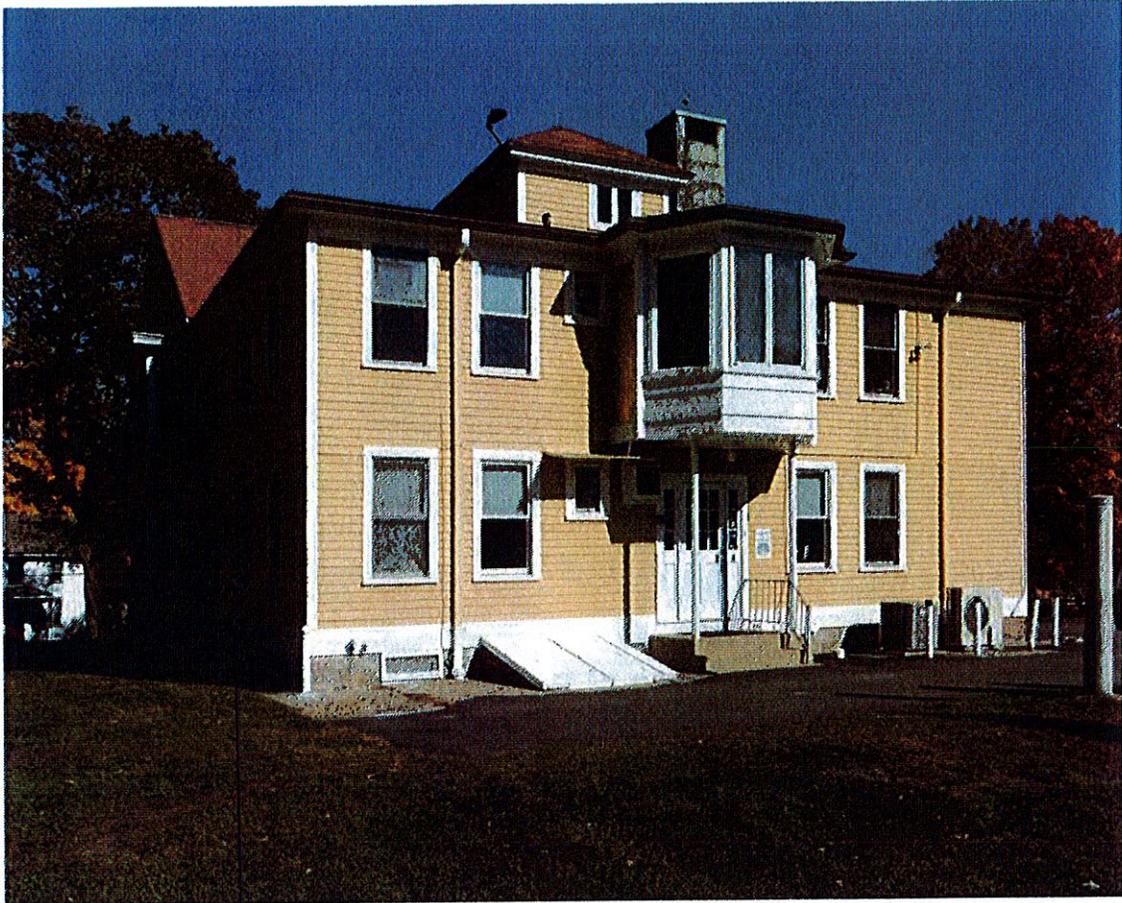
FIGURE 3. SOUTH ELEVATION

The only work that will be visible from the exterior of the building includes a small concrete pad with 4 multi-zone Mitsubishi heat pump condensing units. These will be placed on the southwest side of the building and will not be visible from East Town Street. The dimensions of the condensing units are as follows: 37 ½ w x 13d x 41 ¼ h. Shrubbery will be planted around the condensing units.

Location of Condensing Units

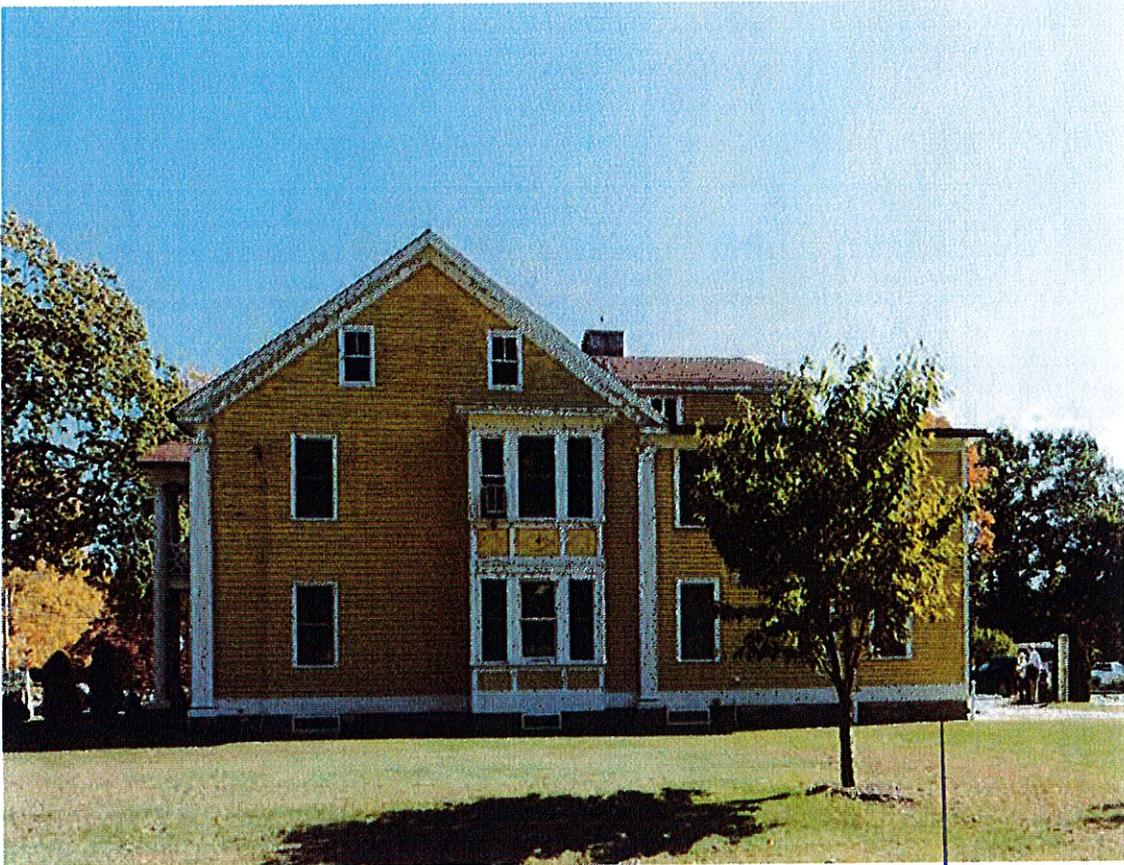
FIGURE 4. WEST ELEVATION

Condensing Units

Infiltration of unconditioned air through door

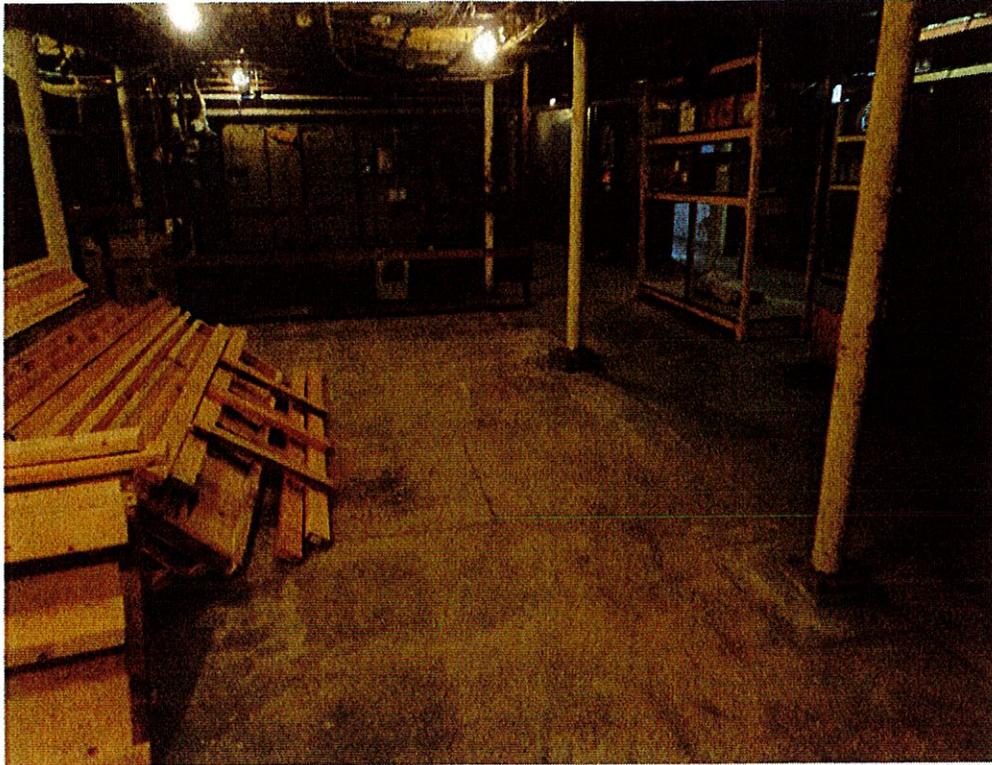
Basement concrete floor is major moisture contributor

Field studies of this building showed that moisture movement is a major player in the building's preservation needs as well as its energy use. On the day of the evaluation the moisture meter measurements in the basement flooring and walls below grade found its masonry concrete flooring to be saturated with moisture vapor. This means that there is no vapor barrier under the concrete foundation flooring or behind the mortared stone foundation walls. Similarly,

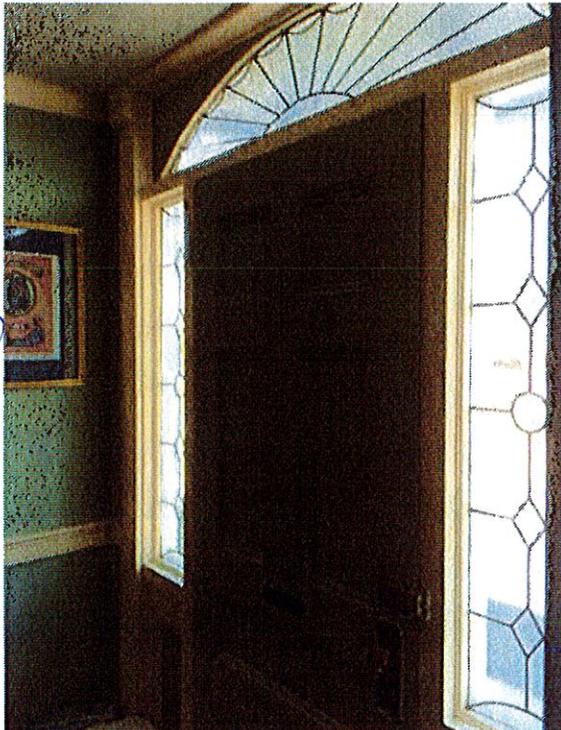
FIGURE 26. DOOR AT EAST ELEVATION. THERMAL PERFORMANCE OF SIDELIGHTS AND TRANSOM WILL IMPROVE WITH INTERIOR REMOVABLE STORM WINDOWS.

Interior Storm Windows installed

Additional minor projects that were recommended as part of this project that have been completed include the following: installing insulation in the attic and roof areas, weather stripping doors, and installing interior storms at door sidelights and transoms.
